Smile Inc Dental Surgeons Pte Ltd

OP3 International Pte Ltd

[2017] SGHC 246

Building and construction law — Scope of works

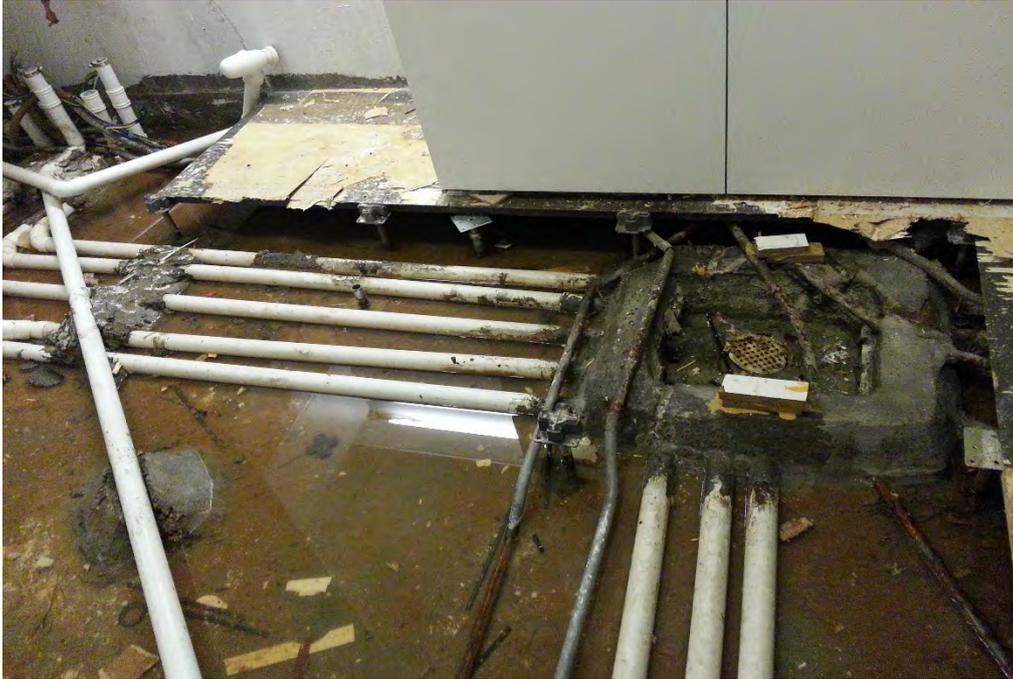
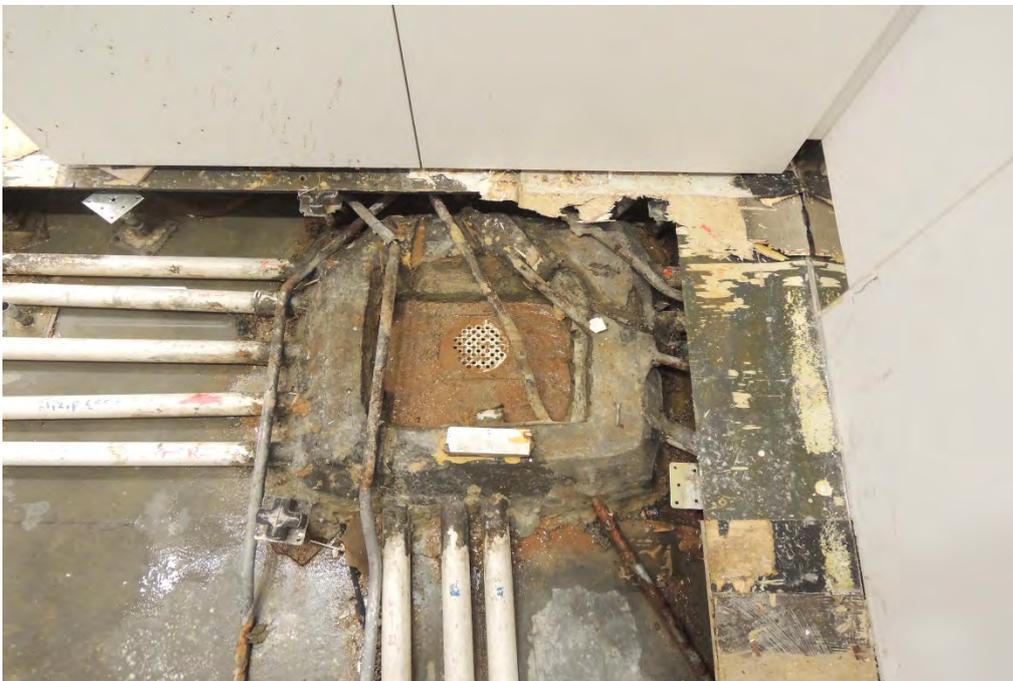
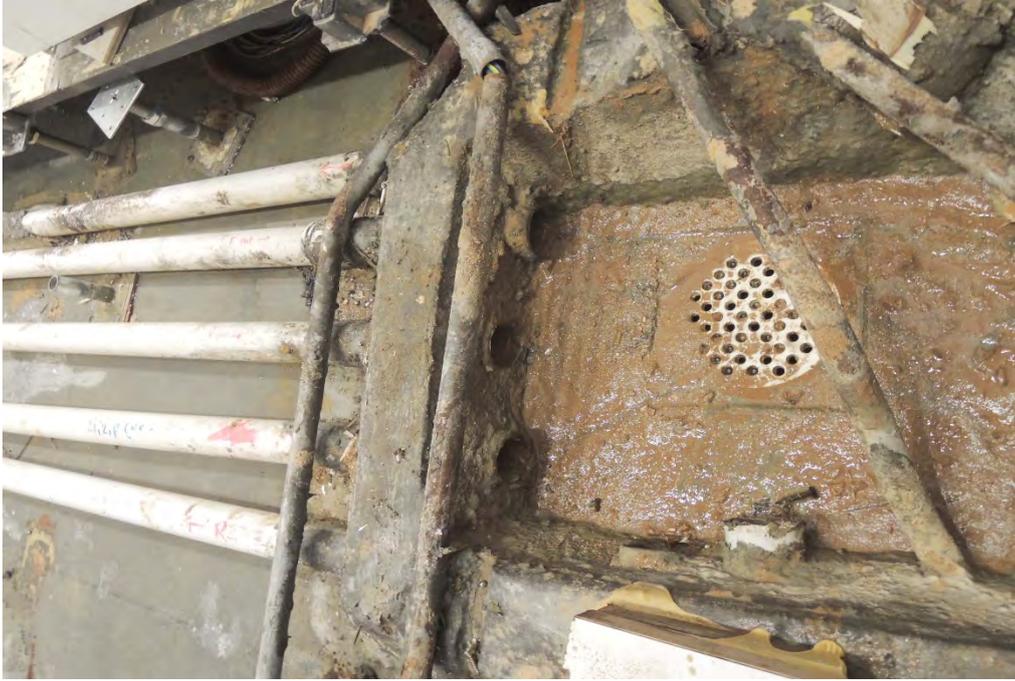
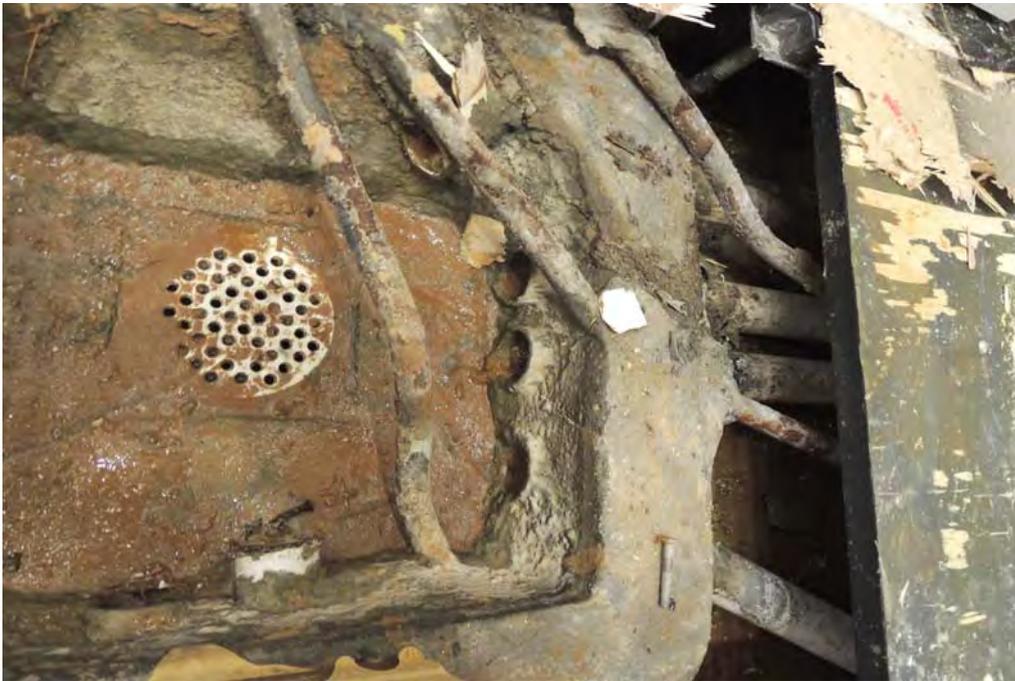
(b) The drainage downpipe for water to be discharged out of the Suntec Clinic (the "Drainage Downpipe") was situated in a raised bunded area (the "Bunded Area"). The Suntec Clinic produced debris, which clogged up the white circular plastic floor grating (the "Floor Grating") that covered the Drainage Downpipe. This caused water to overflow the Bunded Area. (The Bunded Area is 340mm in length and 300mm in breadth, and is enclosed by a bunded concrete wall 65mm in thickness and 100mm in height. The photographs in Annex A to this judgment show the Bunded Area.)

107 For the reasons stated above, I agree with the plaintiff's submission that terminating the nine discharge pipes *above* the Floor Grating, and at the raised Bunded Area, was a serious design flaw, which was the primary cause of the 1st and 2nd Floods. I find that no reasonable contractor would have provided for such a drainage system, which Dr Liew likened to a "death certificate signed" for flooding to occur.⁶³

111 For all these reasons, I accept the plaintiff's submission that the flooding was primarily caused by (a) the termination of the outlets of all nine discharge pipes above the Floor Grating; and (b) the presence of the bunded walls, which prevented water outside the Bunded Area from draining into the Drainage Downpipe.

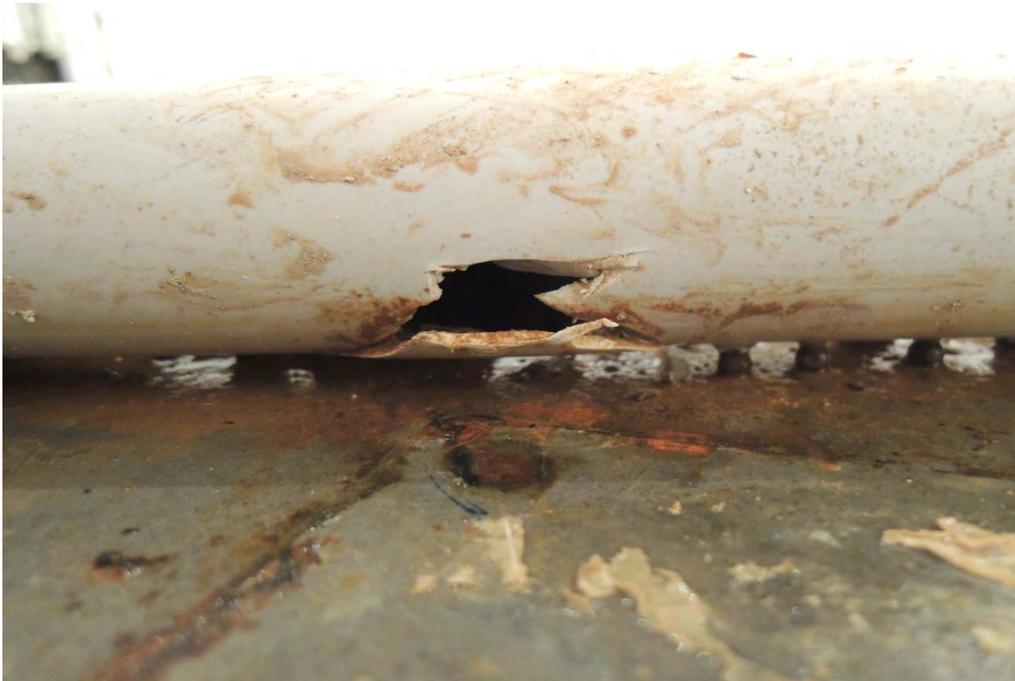
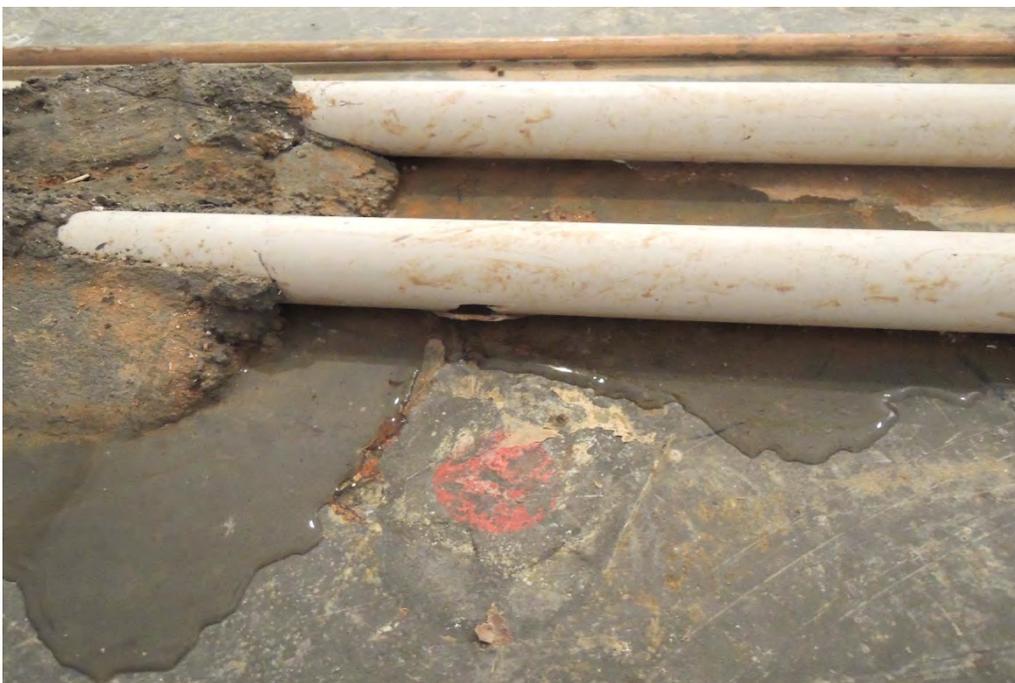
- (a) leakage of water through the hole (see the photographs attached in Annex B to this judgment) in the waste water discharge pipe (the “Drainage Pipe”) from the dental chair in Surgery Room No 3 of the Suntec Clinic;
- (b) the design and installation of nine discharge pipes (the “discharge pipes”) whose discharge outlets were situated above the Floor Grating (see the photographs in Annex A to this judgment); and
- (c) the design and construction of the raised bunds, which prevented water that had overflowed the Bunded Area from draining into the Drainage Downpipe.

48 For the following reasons, I do not accept the plaintiff's allegation, set out in [46(a)] above, that the repeated flooding was caused by damage to the Drainage Pipe (attributable to the defendant). I find that the defendant did not damage the Drainage Pipe.

51 I therefore find that the water leakage test performed using the hydrostatic test method, which were conducted *prior to* the removal of the floor boards after the 2nd Flood, eliminates the possibility that there was a hole or puncture in the Drainage Pipe when the defendant *first* handed over the Suntec Clinic to the plaintiff. The Drainage Pipe, as shown in the photographs at Annex B, was thus not damaged by the defendant during its installation of the raised platform for the floor. I conclude that the Drainage Pipe must have been damaged during the removal of the pedestals and the raised floor platform *after* the 2nd Flood, by the plaintiff's own contractors. The flooding was accordingly not caused by leakage of waste water through the hole in the Drainage Pipe, as postulated by the plaintiff.
